BISMARCK WALKABILITY ASSESSMENT 2023

FINAL REPORT

MARCH 2024

PREPARED BY:
KIM RIEPL
BISMARCK-MANDAN METROPOLITAN PLANNING ORGANIZATION
BISMARCK, ND

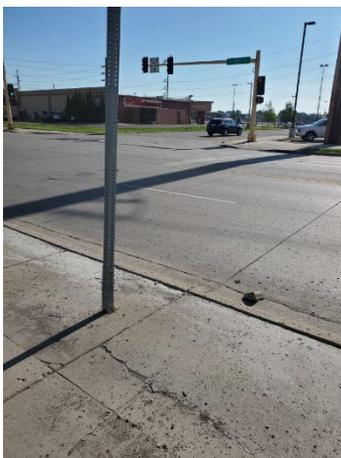
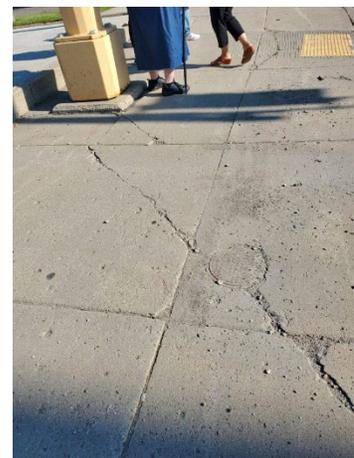
there is no center median, pedestrian island, on-street parking, or bicycle facilities in place. The concrete segments of the sidewalk approaching the intersection have raised and uneven areas and there is cracking, chipping, and flaking as shown in the photos. Additionally, while the width of the sidewalk would be sufficient, it is minimized by signs and poles placed within the pedestrian area.

The landing of the pedestrian crossing features tactile ground surface indicators for pedestrians with visual impairments and includes truncated domes. Another desirable feature is that the ADA ramp launches into the crossing at a perpendicular angle. However, the disrepair of the concrete at the ramp along with the broken curb on either side creates a difficult and hazardous situation for any pedestrian but especially anyone using mobility devices to navigate.

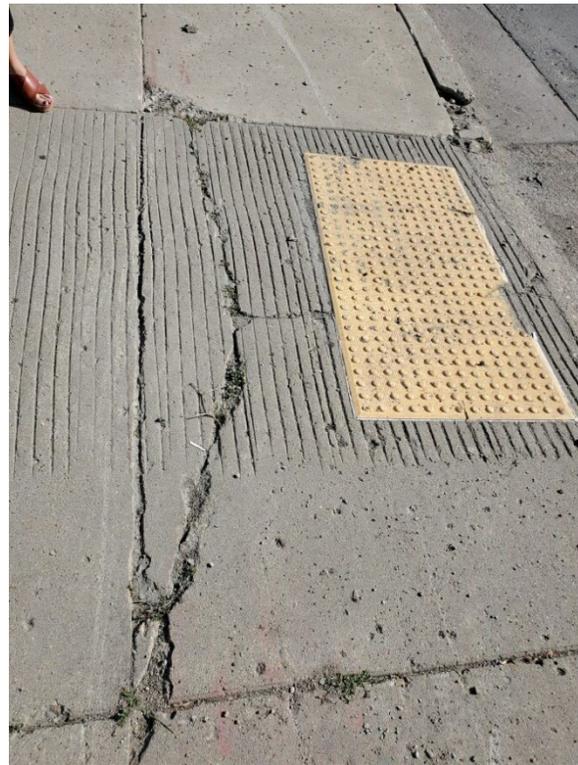
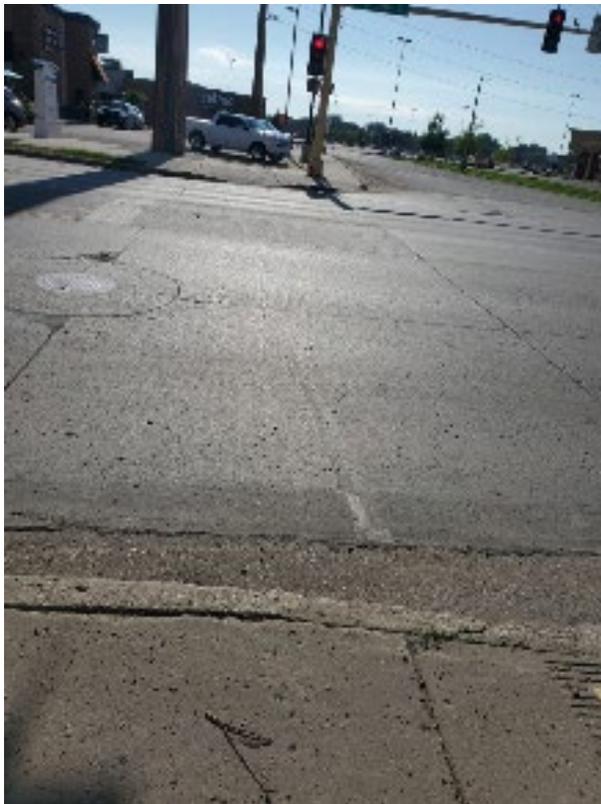
The markings at this pedestrian crossing have worn off and are nearly invisible (*photo, left*). Pavement condition in the crossing is poor. Additionally, the pedestrian crossing signal is not pedestrian actuated and it lacks audible signals. The time provided to cross this wide intersection is 30 seconds, and could be challenging for the mobility impaired, those pushing strollers or navigating the crossing in snowy or less than optimal weather conditions.

Considerations for pedestrian crossing improvements should include, at minimum, high visibility crosswalk markings and the addition of pedestrian actuated/audible signal crossing signals. If a reconfiguration of the roadway or reconstruction is planned for this intersection, raised curb bulb outs or a pedestrian island should be considered to reduce the crossing distance and provide a safer and less intimidating pedestrian experience.

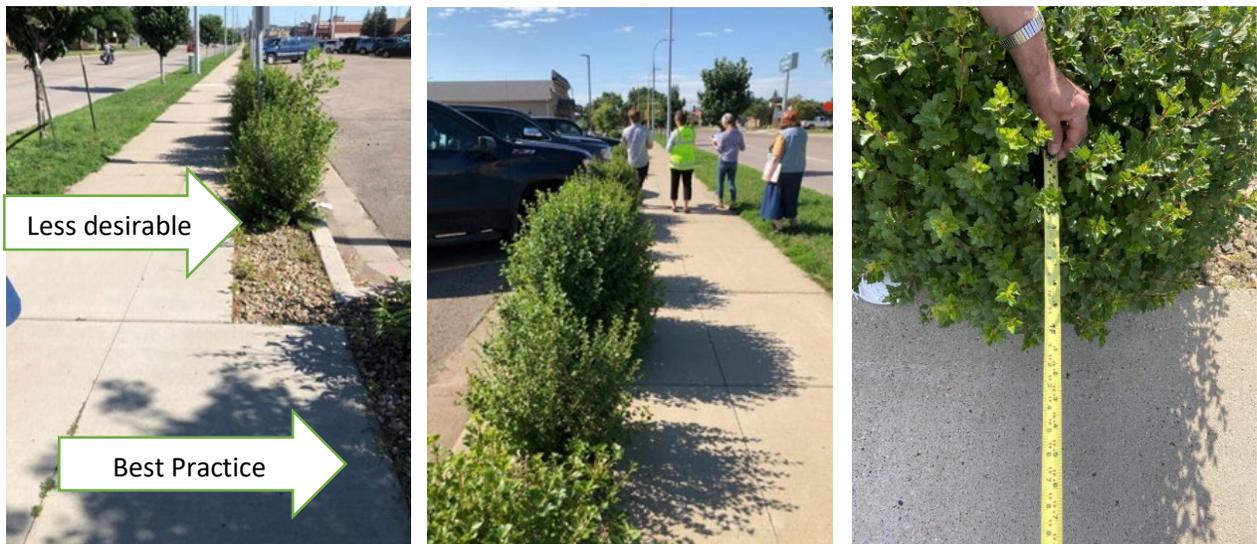
It should be noted the landscaping should be set back from the public right-of-way whenever possible so as not to minimize the sidewalk width (*below left*). Another consideration with landscaping buffers is adequate space allowance for the plant material used. If the space provided outside of the public right-of-way (sidewalk) is insufficient for the size of the mature plant, growth will encroach on the sidewalk area, limiting the width for sidewalk users.

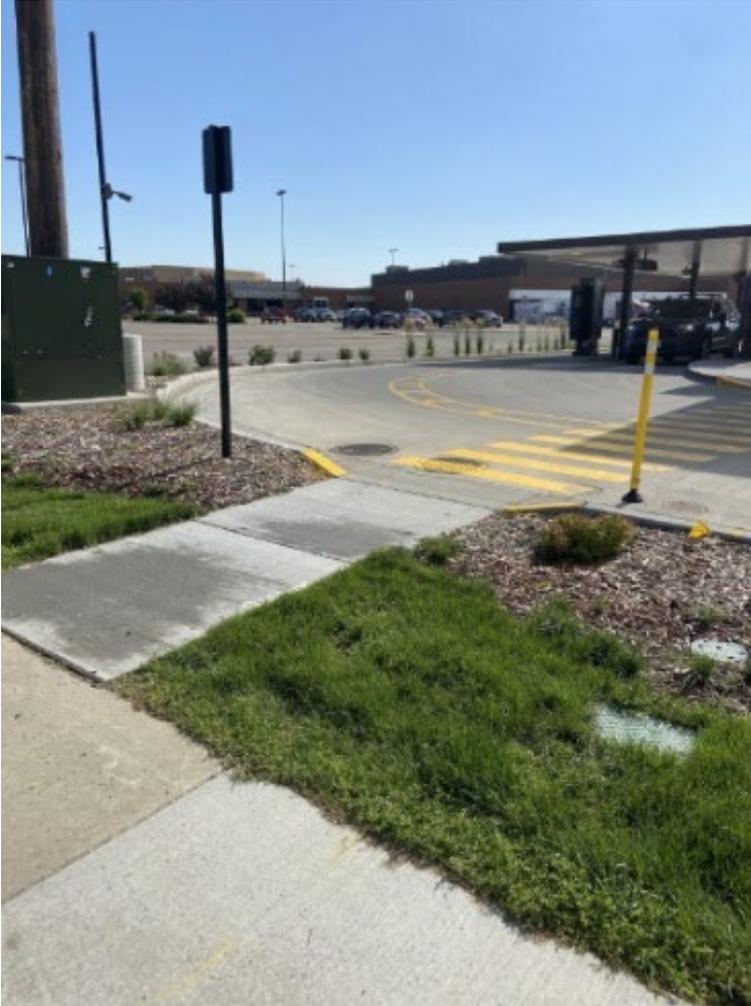
This photo illustrates several “best practice” elements of design standards recommended as safety countermeasures to reduce conflicts between vehicles and pedestrians in drive-thru lane situations, thereby increasing safety.

The restaurant features a drive-thru which provides two lanes for vehicles to use when ordering. The property owner has installed a well-lit and signed ADA-compliant pedestrian crossing at a point that intersects with the drive-thru lanes. The crossing leads from the public sidewalk to the entrance of the building. The crossing is well marked in highly visible paint and also with free standing delineators to alert motorists driving to the pick-up window to be cautious of pedestrians in this area.

Additionally, the photo depicts appropriate and desirable landscaping and buffering techniques to provide a safe and aesthetically pleasing environment for pedestrians and other travelers on this segment of South 3rd Street. All lighting, signs, landscaping and utilities are located in the buffer zone, keeping the pedestrian facility clear without impeding navigation.

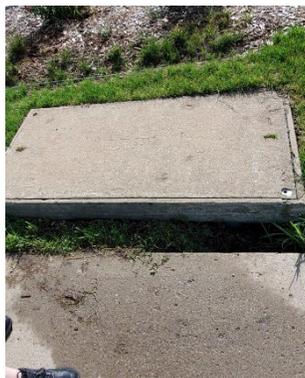
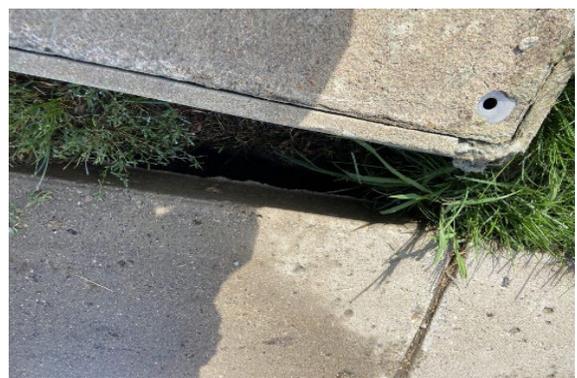
The pictures at the right show a utility access placed appropriately but which presents a hazard by the area that has been dug out bordering the sidewalk. It is large enough that mobility device wheels, bike and stroller wheels, as well as feet, could get caught in this space causing injury.

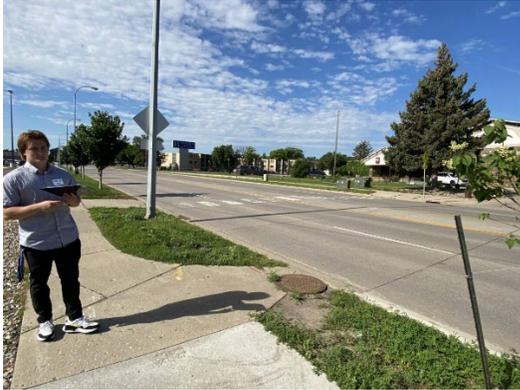
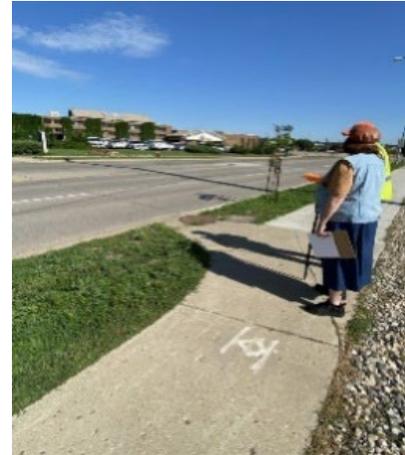
These two photos show a “leg” of the sidewalk extending off from the primary pedestrian facility. It may be mistaken for a pedestrian crossing which it is not. (There is a pedestrian crossing

located further south, as shown in the photo, *above left*).

Additionally, there is a raised utility cover on the northern portion of this “extension”. This concrete segment of sidewalk should be removed, and grass planted to provide consistency with the rest of the sidewalk/boulevard in this area.

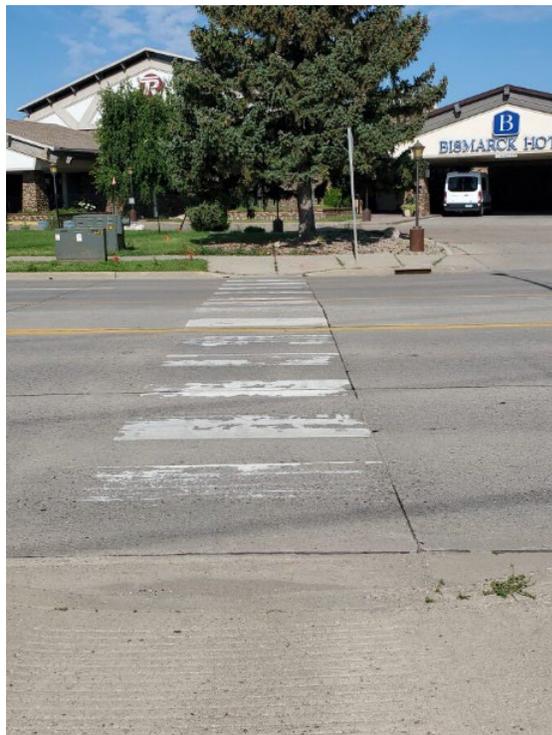
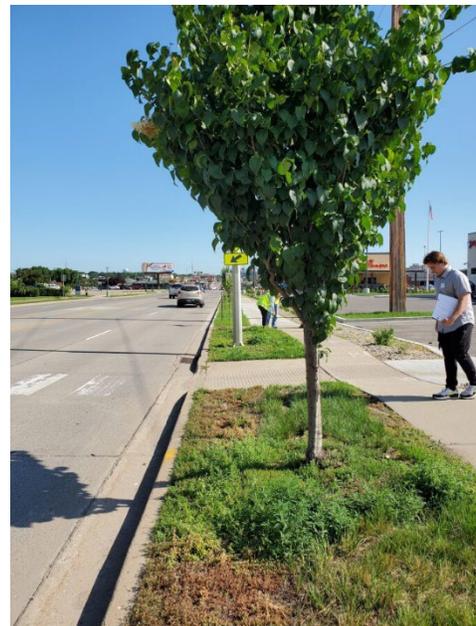
hotel/conference center on the west side of the street and the shopping mall and restaurants on the east side. The ADA compliant ramp does have tactile ground surface indicators so pedestrians with vision impairment will know when the path is ending (*see photo, left*). The crosswalk is marked using a series of closely spaced solid white lines; unfortunately, the markings are predominantly worn off and are not very visible to motorists.

crossing pedestrians. Although there are pedestrian crossing signs located on both sides of the road, both approaching the crossing and at the crossing, to alert approaching motorists, care must be taken to ensure they are visible and not obstructed by the boulevard trees, as shown (*photo, right*).

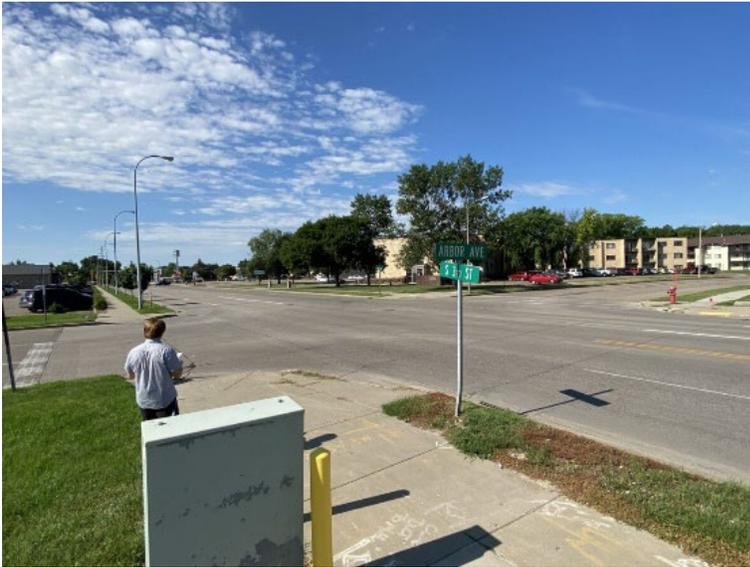
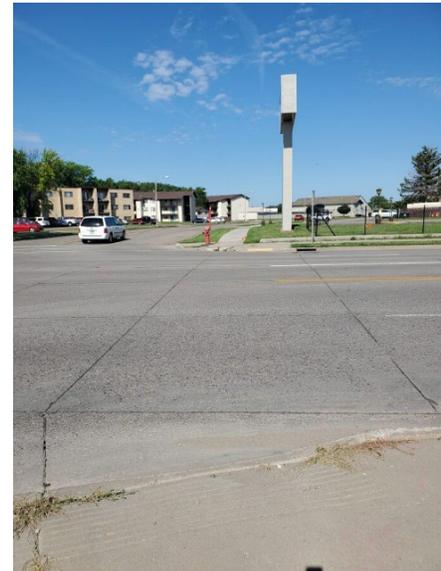
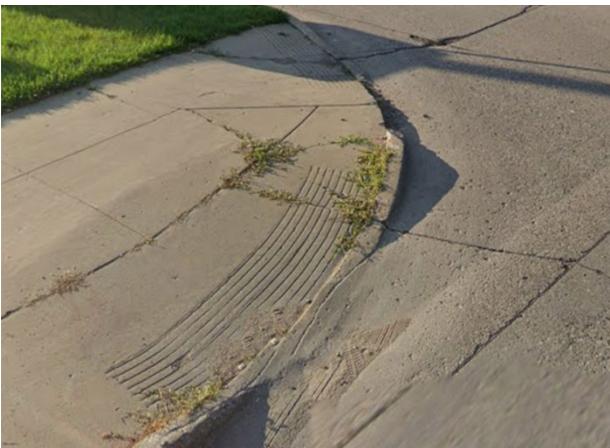
leg serves as access to the shopping mall and has lane striping and a stop bar marking (*top left*).

The ADA ramps are offset and the curb is broken and crumbling. This pedestrian crossing should be reconstructed to correct the offset of the ramps, add truncated domes to the ramps, and provide highly visible pedestrian crossing pavement markings both for southbound crossing and for westbound crossing maneuvers.

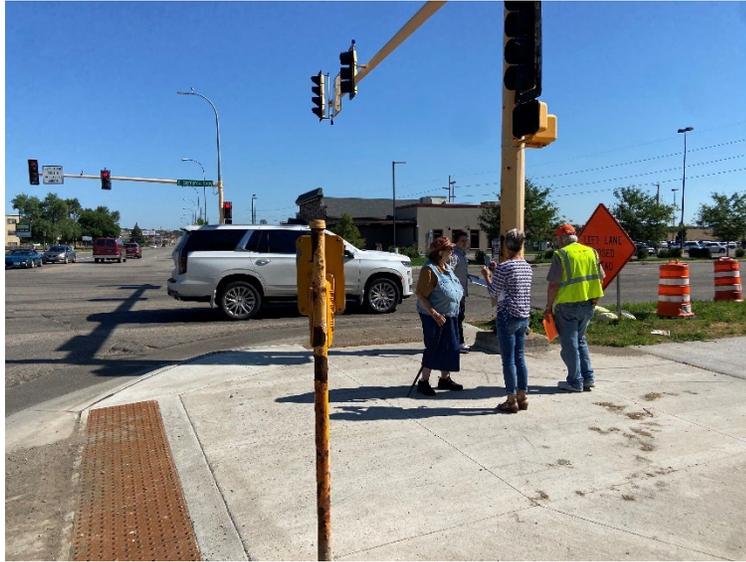
surface material is new and consistent, the space in the pedestrian launch/landing area is wide and comfortable (*left*).

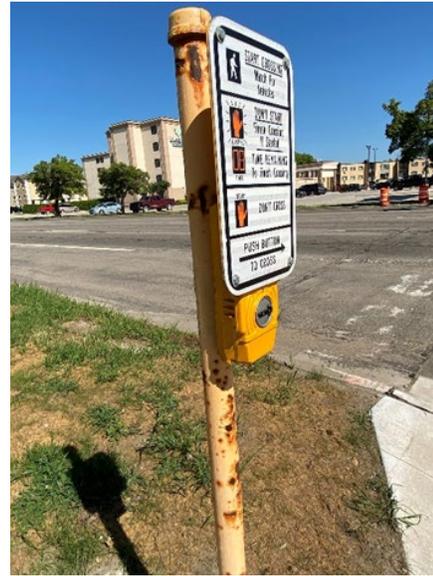
and comfortable (*left*). There are clearly visible traffic lights at this intersection along with pedestrian actuated walking signals (*below*).

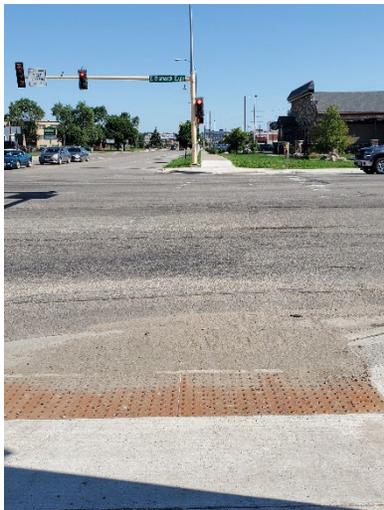
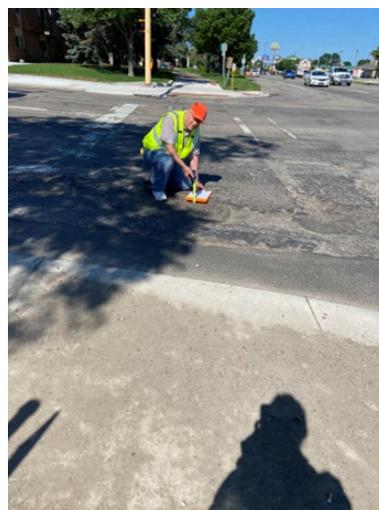
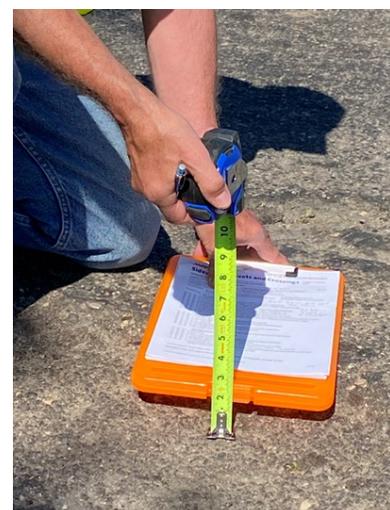
The pedestrian crossing signals have audible prompts for people with vision impairment, however, the volume was not sufficient to be easily heard over the passing morning traffic which was comparatively light. Peak traffic times in the morning and late afternoon/early evening would likely be louder due to the increased number of vehicles, making the audible signal even more difficult to hear. There is a 25 second crossing time allowed by the signal, which is sufficient time to cross but only if the pedestrian's physical ability as well as weather/roadway conditions are at ideal levels. Snow or ice on the ramp or roadway, as well as deposited debris or sand from road maintenance operations can impede passage or maneuverability, (*below left*) particularly if using any type of mobility device. Uneven pavement meeting the ramp can also impede travel through crossings, creating a need for longer pedestrian crossing times (*below middle, and right showing a +2" differential in the pavement level due to patching*).

The pedestrian crossings at this intersection all require new pavement markings. This intersection experiences high traffic volumes throughout the day, but especially at peak travel times, along with consistently high pedestrian and bicycle use. The photo (*below, somewhere*) illustrates the importance of providing pedestrian crossings that are highly visible.

Additionally, the uneven pavement conditions near the pedestrian ramps, which may exist either because of the recent construction or as a result of prior asphalt patching performed as road maintenance, should be noted for improvement.

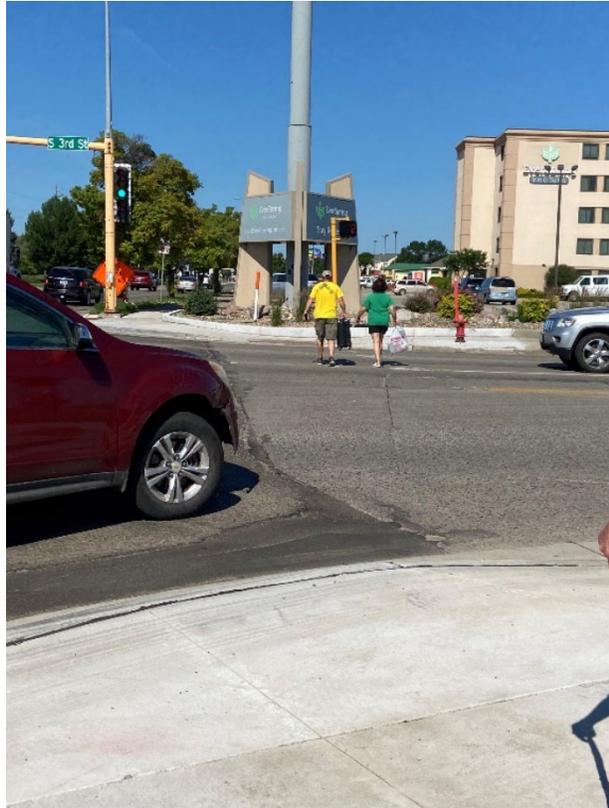
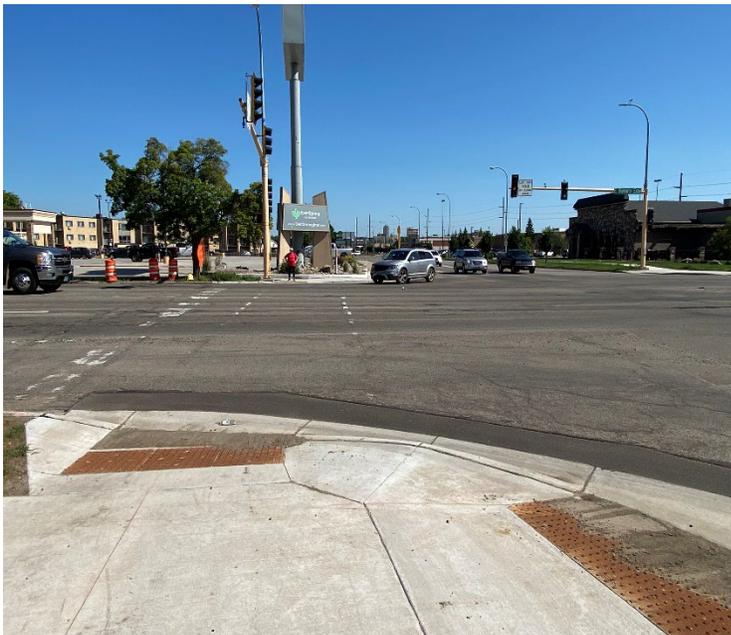
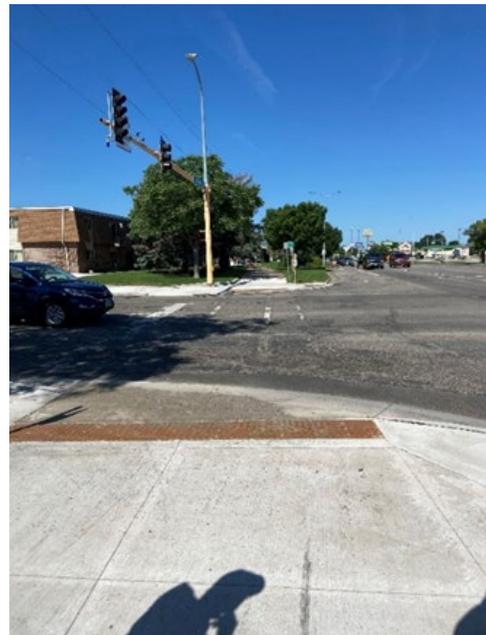
It appears in the photos that an effort was made to blend the road elevation to the elevation of the area near or at the ramp. The photos further illustrate conditions that make using the crossing difficult for some users, such as accumulation of debris at the base of the ramp, large cracks or variations in the pavement levels. The lack of pavement markings for the crossing make it difficult for persons with visual impairment to discern the crossing area.

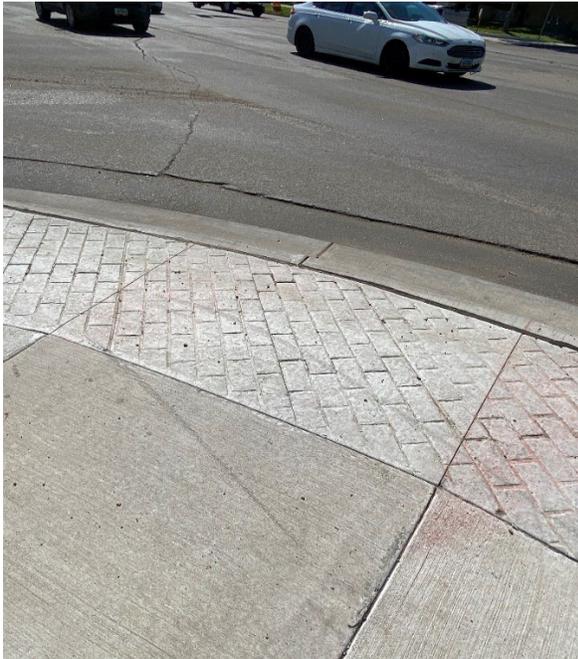
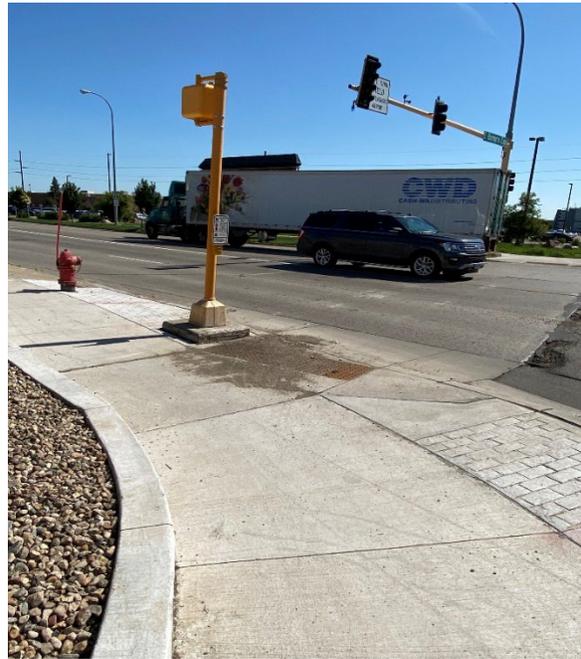
The northwest quadrant of the intersection provides a buffer area of stamped concrete between the sidewalk and roadside curb. The stamped concrete provides a tactile indicator to the limit of the sidewalk for visually impaired persons and the buffer area provides adequate space for placement of signage, utilities, poles, etc. Additionally, there is a raised curb between the sidewalk in the public right of way and the adjacent private property.

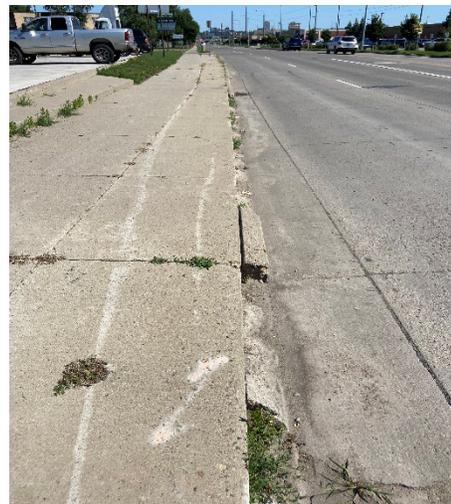
This short stretch of S. 3rd Street provides no bicycle facilities, although the sidewalk is wide enough to accommodate bicyclists at 9.5' in width. However, the sidewalk is in poor condition, overall. There is cracking and heaving, weeds growing through the cracks, and broken and crumbling curbs on both the interior and the street side of the sidewalk. There is no tactile indicator or buffer area between the sidewalk and the crumbling curb or roadway.

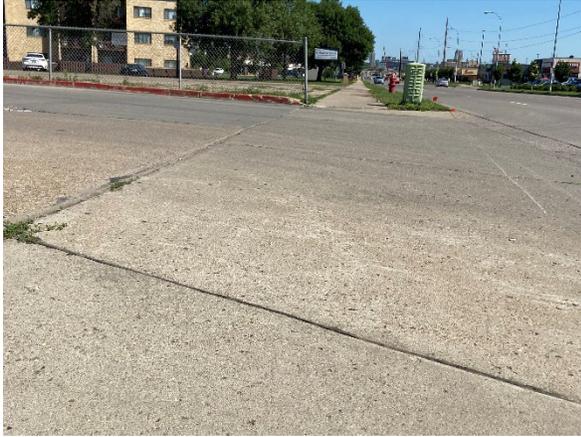
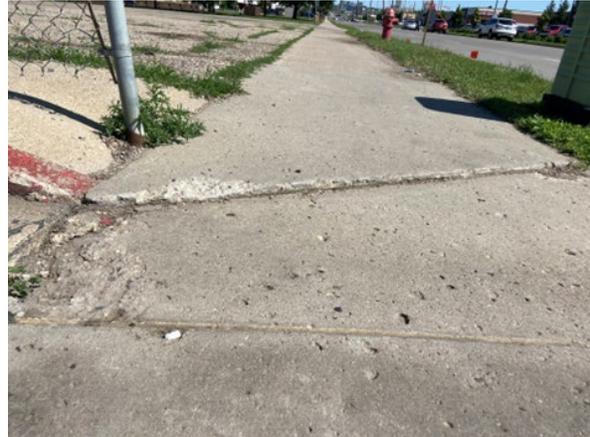
The sidewalk area along the west side of 3rd Street was interrupted by three separate driveways of varying widths and condition. While the northernmost driveway was acceptable, the other two were in varying states of disrepair with cracked concrete and having slopes that appeared to exceed the ADA/ABA 1:20 side slope tolerance. This would have to be measured and calculated to confirm, however, and these are private driveways. City design standards addressing slope tolerance for new concrete pours and construction help maintain compliance with ADA industry standards. Until such time as this sloped driveway is replaced, it should be identified as a gap in the sidewalk network.

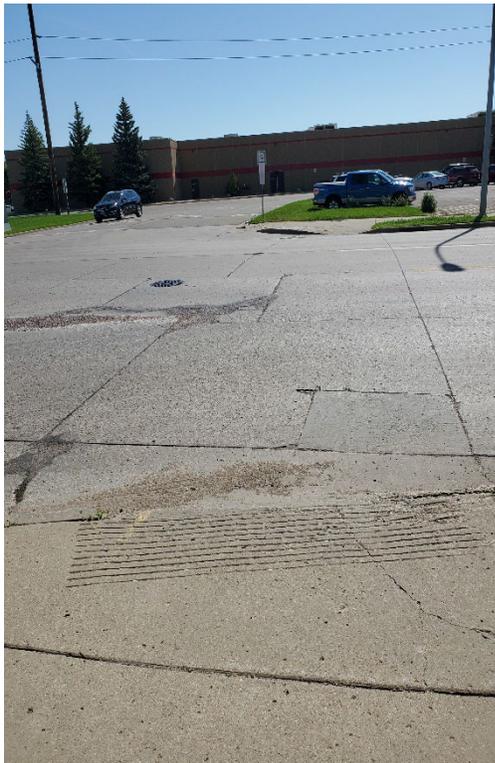
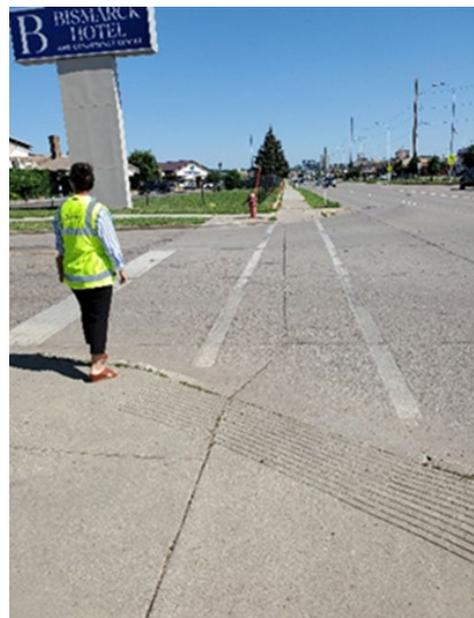
The intersection at 3rd and Arbor Avenue includes curb cutouts for ADA ramps with tactile indicators at the base of each ramp. However, the ramps are offset diagonally, resulting in a diagonal departure and travel direction. The curb area around the ramp is not consistent; but has breakage and is crumbling. The pavement condition on 3rd Street (*photo, left*) is uneven, cracked and is poor enough to make navigating this unmarked pedestrian crossing challenging, particularly for the visually impaired or those using mobility devices.

While the crossing on Arbor Avenue is marked, it faces the same challenges with the diagonal offset and condition of the ramps. This entire corner

should be reconstructed to include ADA compliant ramps that include high visibility truncated dome pedestrian pads which have a primary travel pattern perpendicular to the sidewalk. Ideally, this intersection would benefit from a Rectangular Rapid Flashing Beacon (RRFB) to alert motorists to pedestrians crossing 3rd Street at this intersection.

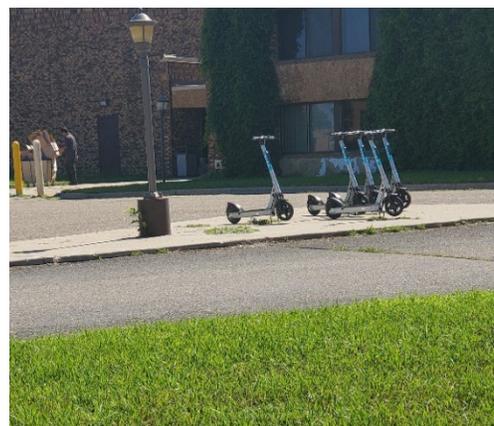
Additionally, although no pavement markings for the pedestrian crossing may be acceptable as the speed limit on these streets is 25 mph and the motor vehicle traffic is light, markings are preferred. Bicycle facilities, such as a "Share the Road" on-street painted bike lane should be considered. There is a fair amount of bicycle traffic, as well as E-Scooter usage in the area between the residential and commercial locations.

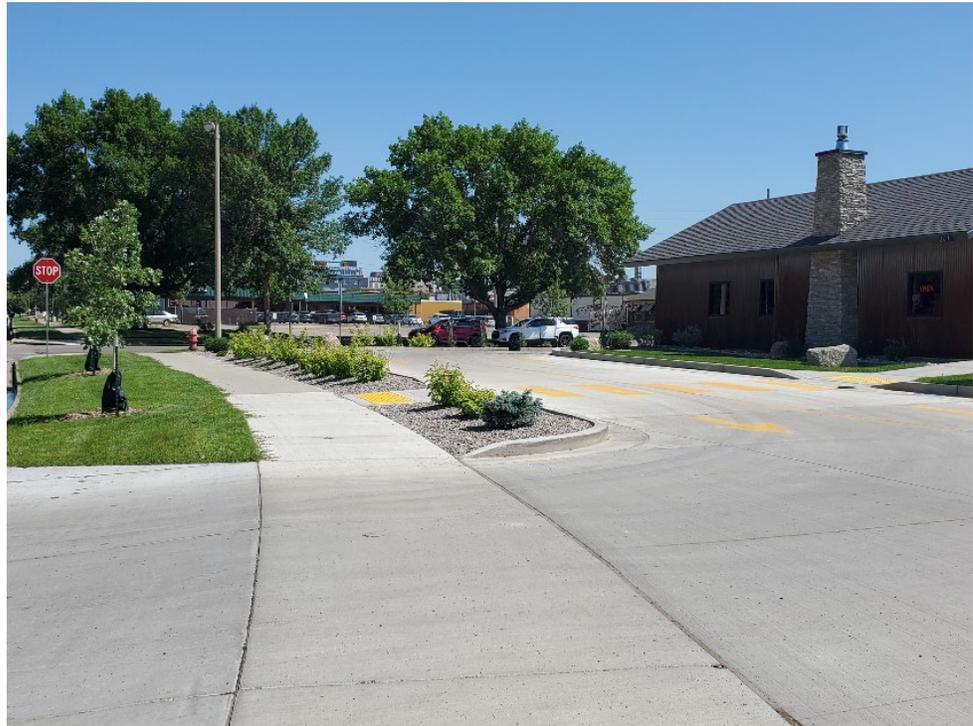
A new business has been constructed at the corner of S 2nd Street and Indiana Avenue since the previous walk audit was completed in 2017. Many best practices have been incorporated in the design of the pedestrian facilities and accommodations, as shown in the photo (*below*). The

main driveway into the business is level, with no cross slope affecting the pedestrian sidewalk. Beyond that, there is a 10' wide grass covered boulevard that provides area for shade trees, signs, and utilities. There is a landscaped buffer area between the sidewalk and the parking lot which has a drive through

exit lane. There is a raised curb on the interior of the landscaped buffer and a cutout through the buffer that includes a level pedestrian sidewalk to provide safe access to the business. It is marked with high visibility painted markings to alert motorists to the potential of pedestrians crossing in this area. This is a pleasant area to walk with ease and the features described help provide a sense of separation and safety from the moving motor vehicle traffic on all sides. This specific location within the audit route was deemed to be an excellent example of how the built environment can promote walkability.
