# **BISMARCK WALKABILITY ASSESSMENT**

## **FINAL REPORT OCTOBER 2025**

PREPARED FOR:  
BMMPO BICYCLE-PEDESTRIAN SUBCOMMITTEE

PREPARED BY:  
STEPHEN LARSON  
BISMARCK-MANDAN METROPOLITAN PLANNING ORGANIZATION  
BISMARCK, ND

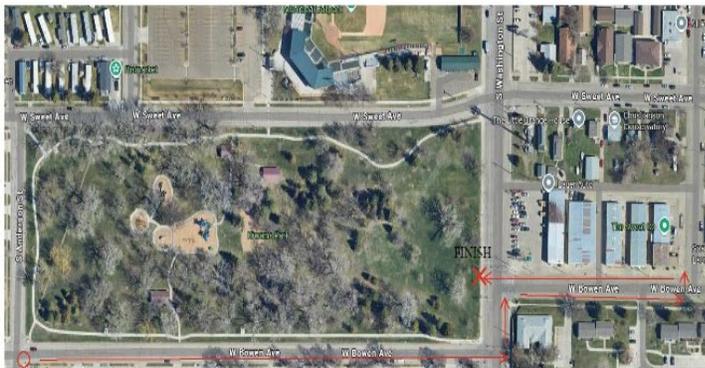
The point of beginning for the walk audit route was at the intersection of South Anderson Street and West Bowen Avenue. The route included approximately 4 cumulative block lengths of Bowen Avenue to assess (3 blocks on the south and 1 on the north side of the street), along with 2 separate intersection segments. (See map, above left.)

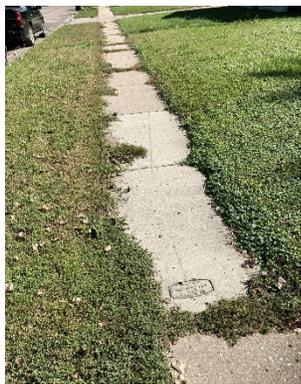
### **Bowen Avenue from Anderson Street to Washington Street (south side)**

The roadway comprising this segment is bi-directional with two driving

lanes. The speed limit is 25mph and the intersection of Anderson and Bowen is governed by a 4-way stop sign with marked pedestrian crossings and ADA ramps (all in good condition). There is a sidewalk of a respectable width on both sides of Bowen Avenue, and the roadway has signs to mark it as a Capital Area Transit (CAT) bus route, and to designate the school zone for the high school to the west. The sidewalk on the south side of Bowen Avenue shows significant overgrowth in places (*photo, left*) and significant cracking and wear in other places (*photo, above right*).

Considerations for pedestrian improvements should include sidewalk repairs and removal of vegetative sidewalk obstructions.

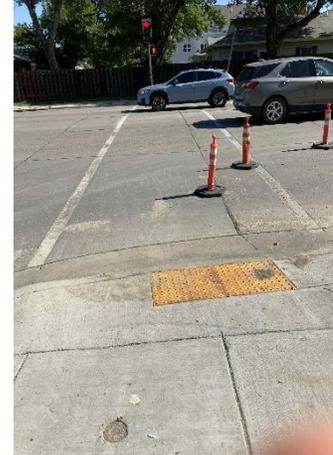
#### **Bowen Avenue and Washington Street Intersection (south side)**

Washington Street is bi-directional with 2 southbound and 2 northbound driving lanes, and a center turn lane. The posted speed limit is 35 mph. There are no bicycle facilities here. The pedestrian crossing of Washington is clearly marked, with ADA ramps and a push-button signal (*photo top right, page 4*). The sidewalk and ADA ramps are in good condition, and the signal works well (although it does not have audible prompts for the visually impaired). Washington Street is very wide and feels uncomfortable to cross. The crossing is on the south side of Bowen; there is no crossing on the north side, and the crossing here is the only east-west

pedestrian crossing of Washington between Front Avenue and Arbor Avenue, despite the significant pedestrian traffic on both sides of this corridor.

Pedestrian improvements at this intersection should include the addition of an audible prompt for the crossing signal, and the potential installation of curb bulb-outs or a median. Additional east-west crossings of Washington Street should also be investigated between Front and Arbor, especially in areas where there are apartments (towards Arbor) and the ballpark (close to Sweet).

**Note:** The City of Bismarck has a project scheduled for 2027 (PCN 24625) in this area to remove both traffic signals at Washington and Bowen (replacing them with stop signs governing traffic turning onto Washington) and move the pedestrian crossing north to a location between the two intersections, where Rectangular Rapid Flashing Beacons (RRFB) and a median refuge island will be installed for pedestrians. This project has the potential to address the concerns noted above.

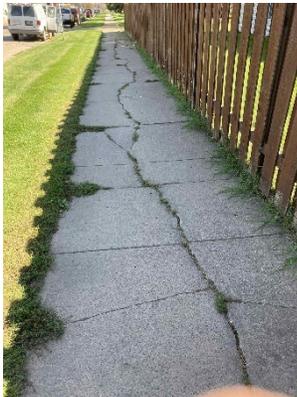
#### **Bowen Avenue from Washington Street to Mandan Street (south side)**

The roadway comprising this segment is bi-directional with two driving lanes. The speed limit is 25mph, and the street has a sign marking it as a CAT bus route. The sidewalk is a good width but its condition is mixed; some portions are good, others are very poor (*photo, left*).

Pedestrian improvements on this segment should include sidewalk repairs for deteriorated sections.

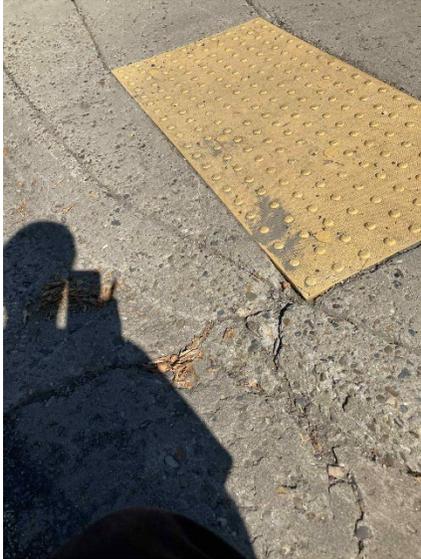
**Bowen Avenue and Mandan Street Intersection**

There is no north-south pedestrian crossing of Bowen at this location (*photo, right*); the closest marked pedestrian crossing of Bowen is three blocks east at 3<sup>rd</sup> Street. There is also no curb ramp onto Bowen from the south side of the roadway, and on-street parking reduces visibility for pedestrians attempting to cross. There are several important businesses (such as a laundromat) and many residences in this area, making north-south crossings an important upgrade for this roadway. On the north side of Bowen, the east-west crossing of Mandan Street has ADA ramps, but no pavement markings. The pavement around

Pedestrian improvements at this intersection should include the addition of an appropriately marked, ADA compliant north-south pedestrian crossing, any necessary sidewalk repair along the east-west crossing, and the addition of pavement markings for the east-west crossing.

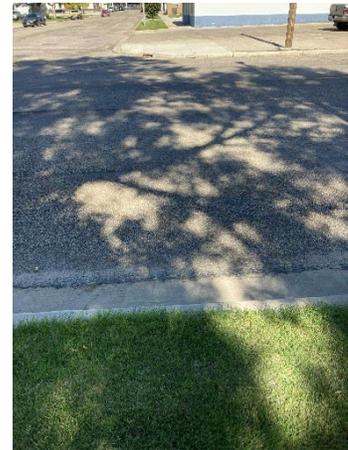
the ramps also shows some signs of wear (*photo, left*).

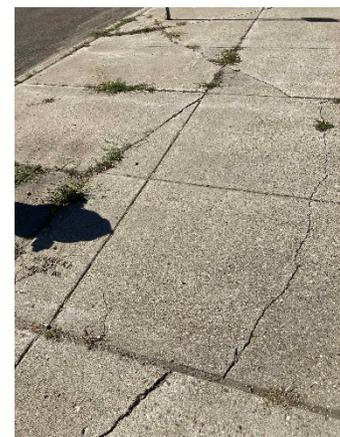
**Bowen Avenue from Mandan Street to Washington Street (north side)**

As previously noted, Bowen Avenue is a bi-directional, 25mph roadway which also serves as a bus route. The sidewalk along this segment is double-wide, with a bonus boulevard area immediately adjacent to the sidewalk. There is extensive cracking and wear showing throughout the segment (*photo, right*). Sidewalk repairs should be considered here.

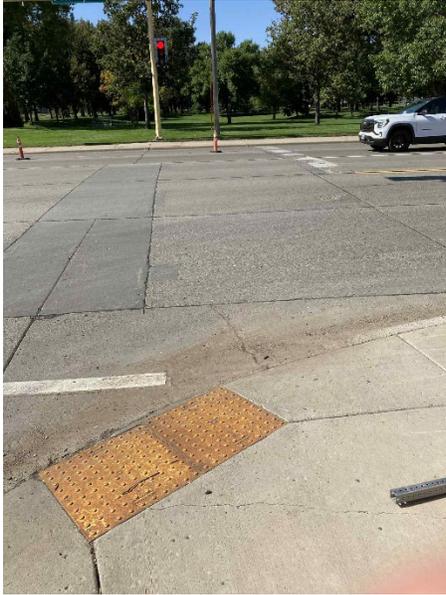
### **Washington Street and Bowen Avenue Intersection (north)**

The north-south crossing of Bowen Avenue is marked with ADA ramps and is in good condition, however, the northern segment of Bowen Avenue lacks east-west crossings of Washington Street on either the north or south sides of the street (*photo, left*). The width and business of Washington Street makes crossing at this location unfeasible.

Pedestrian improvements at this intersection would include a marked crossing of Washington Street with appropriate safety features. The City of Bismarck’s anticipated 2027 project for an RRFB crossing with a median will hopefully resolve this concern.

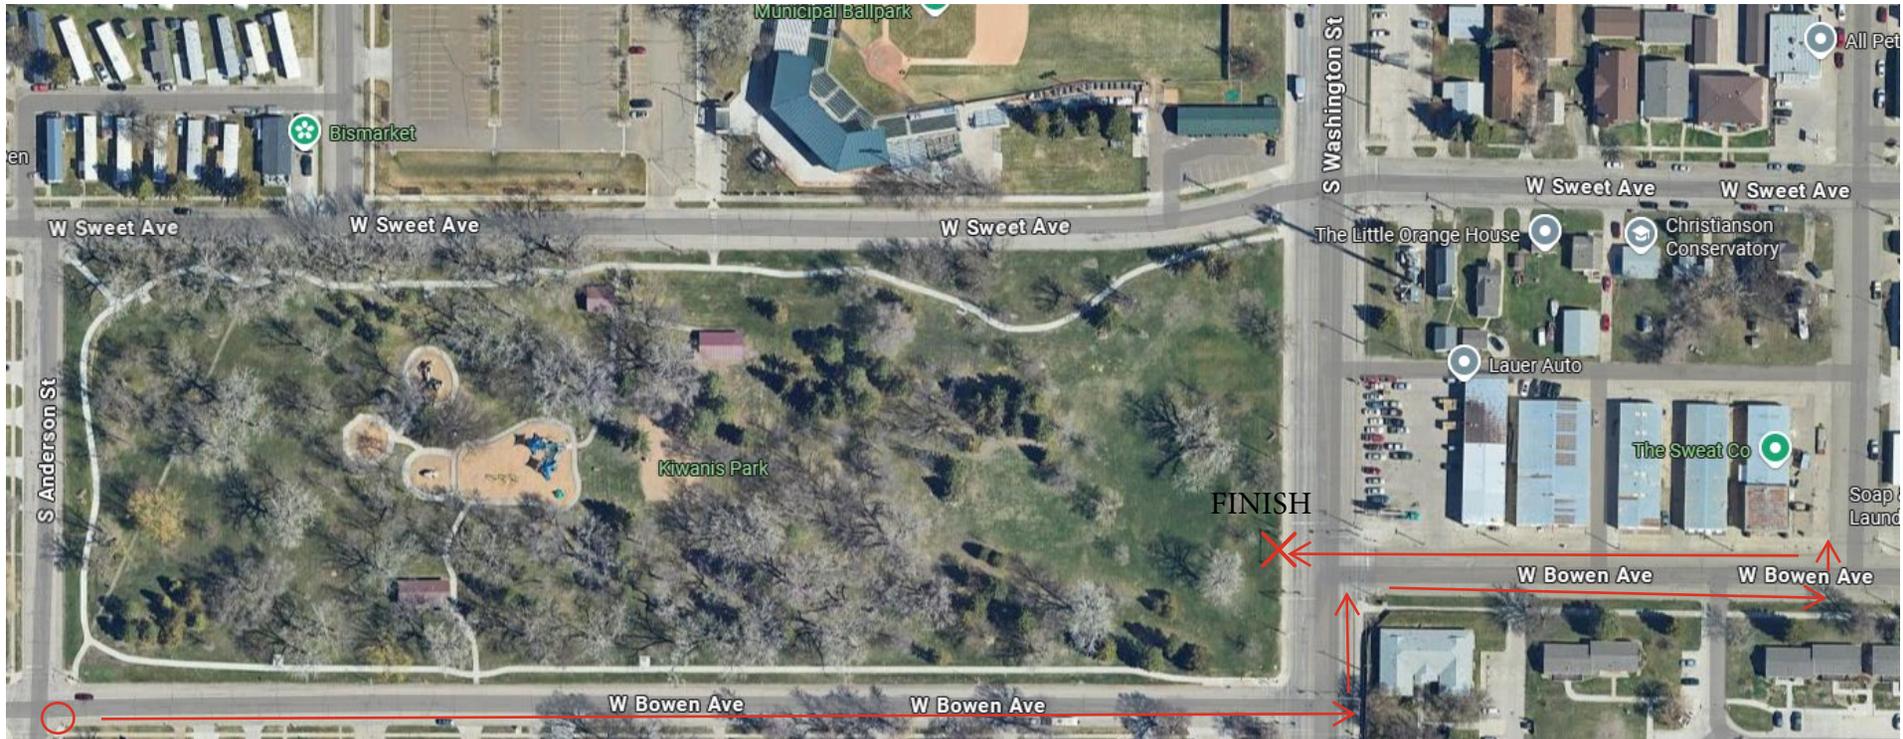
## Bismarck Walk Audit Route, September 2025

We will begin on the south side of W Bowen Ave, walk east and cross S Washington St, walk a short distance north then walk east along Bowen to S Mandan St, cross Bowen walking north, then turn west and return to S Washington St, where we will cross Washington for a final time walking west.
