BISMARCK WALKABILITY ASSESSMENT 2023

FINAL REPORT

MARCH 2024

PREPARED BY:
KIM RIEPL
BISMARCK-MANDAN METROPOLITAN PLANNING ORGANIZATION
BISMARCK, ND

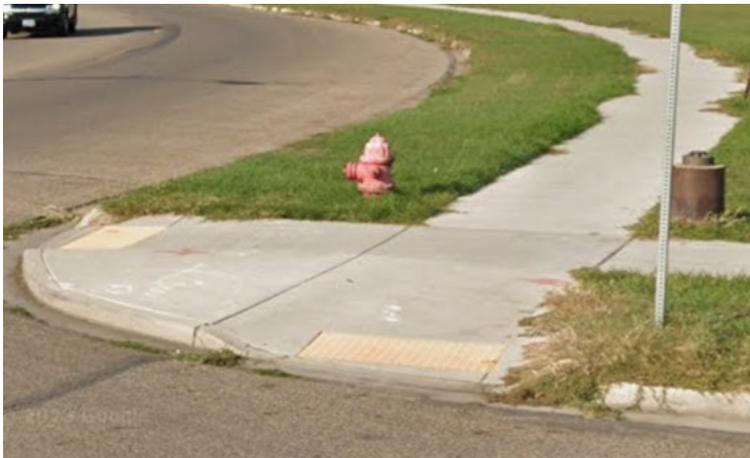
It was beneficial to include this segment in the route alignment to observe potential improvements that may have been made resulting from recommendations provided in the 2017 walk assessment. It was noted in that report that E Arbor Avenue was lacking in sidewalks, recognized by the auditors at the time as a notable pedestrian infrastructure gap to be addressed.

Since that time, sidewalks have been installed on both the north and south sides of Arbor Avenue, as well as along the east side of S 2nd Street (there were existing sidewalks on the west side). The sidewalks are poured concrete, vary between 4.5' and 6' in width, are free of cracks or other obstructions, and are level, overall. They terminate at the street with a curb cutout for a ramp that is ADA compliant and include high visibility
